FIVE-YEAR REVIEW

NORTHWEST TRANSFORMER
SOUTH HARKNESS SITE
EVERSON, WASHINGTON

**FINAL FIVE-YEAR REVIEW
NORTHWEST TRANSFORMER
SOUTH HARKNESS SITE
EVERSON, WASHINGTON**

September 11, 1998

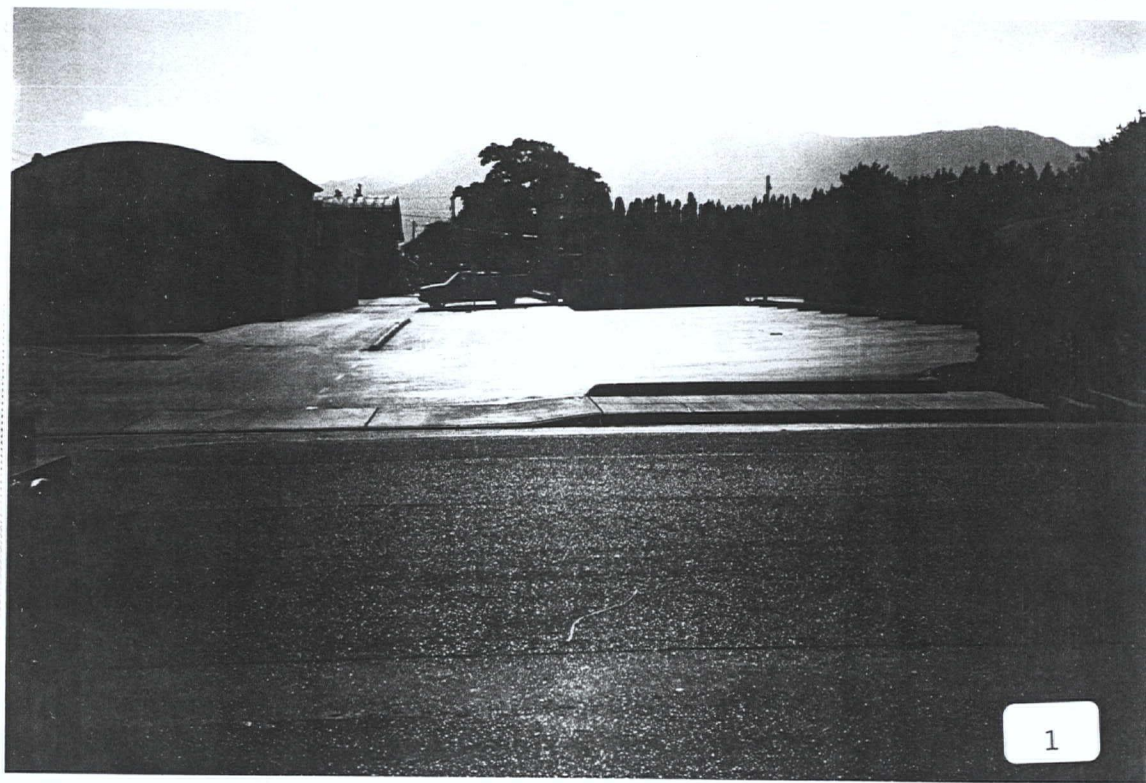
- 1) Looking east from across street (Harkness) from in front of post office.

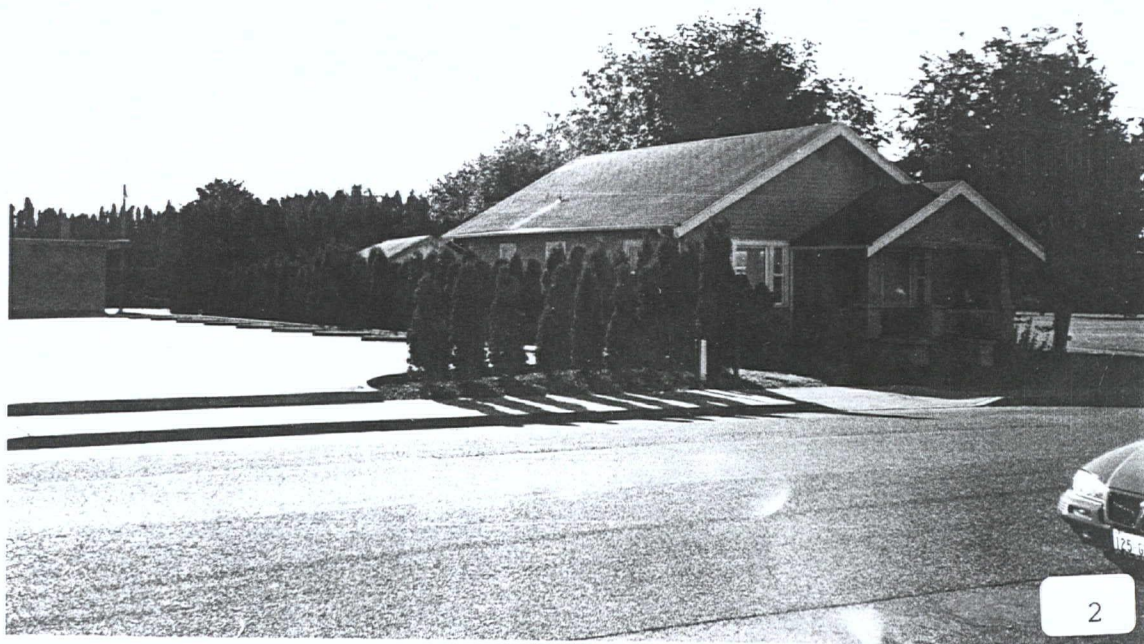
- 2) Looking southeast from across S. Harkness Street, from in front of post office.

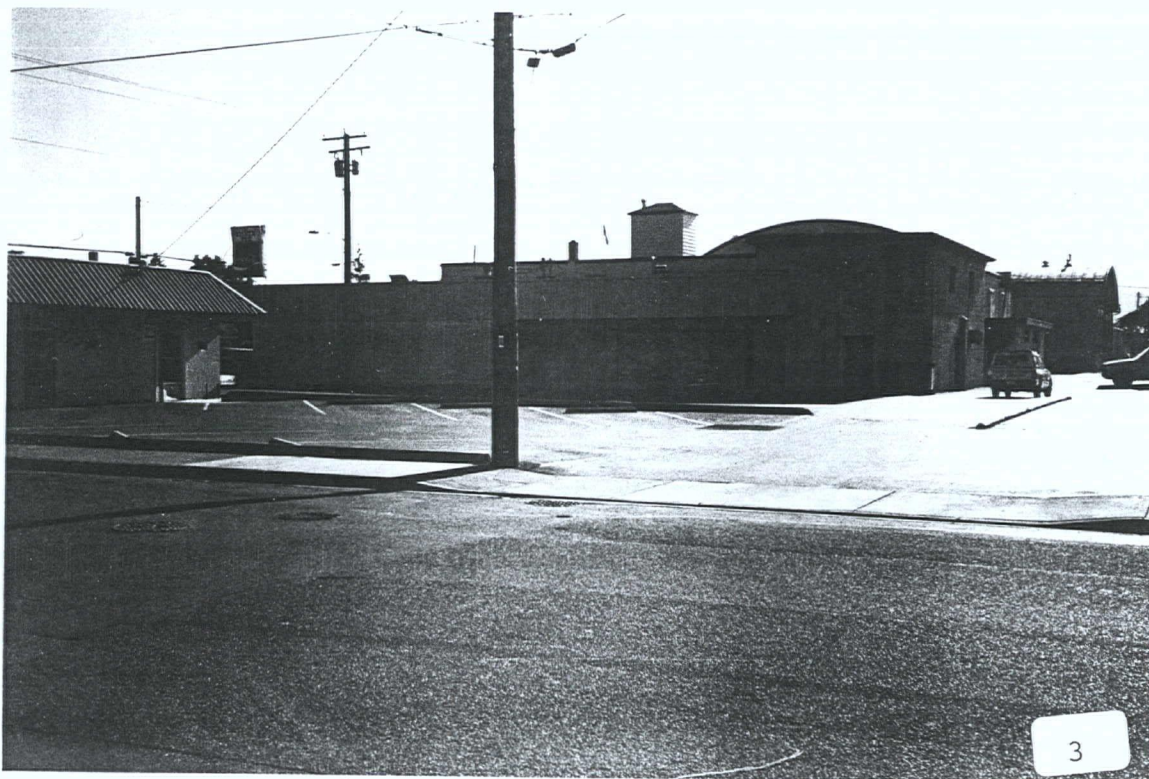
- 3) Looking northeast from across S. Harkness Street, from in front of post office.

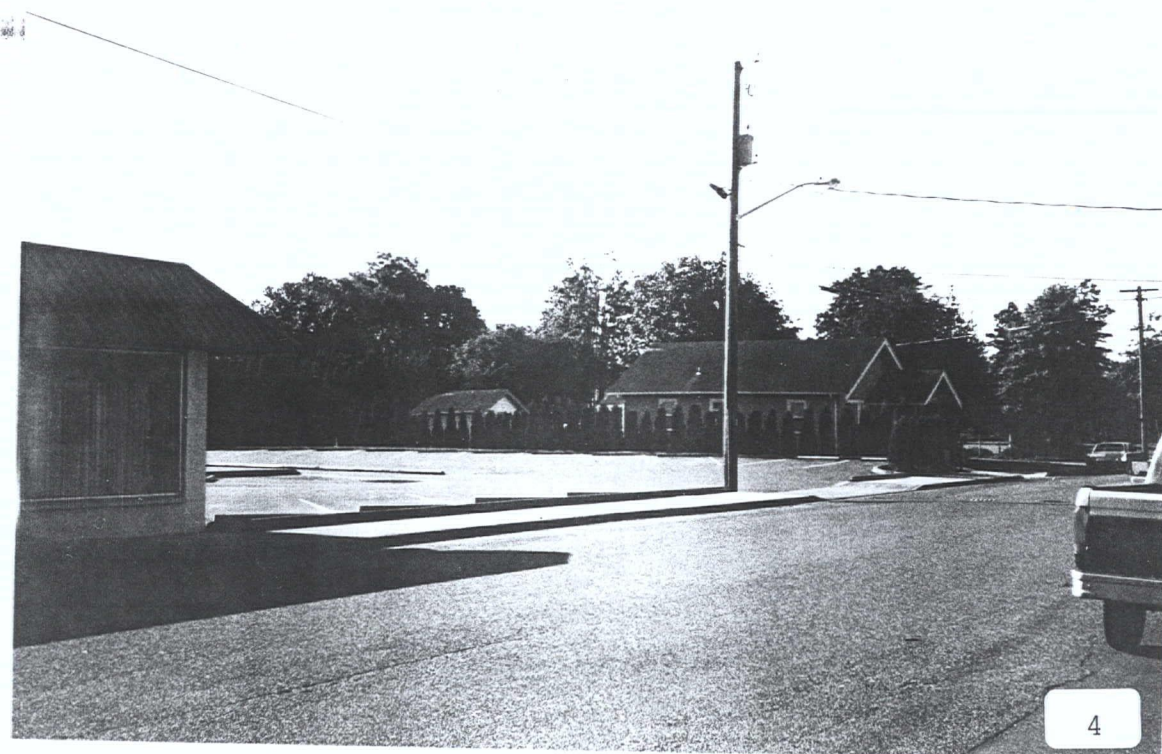
- 4) Looking southeast from southwest corner of Main Street and

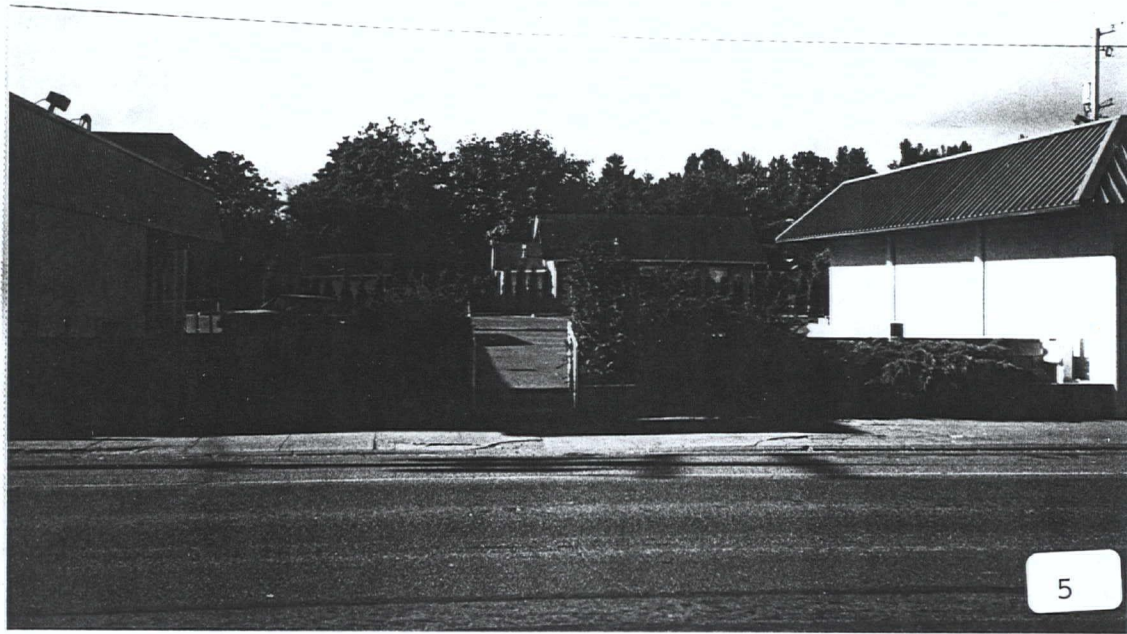
5) Looking south from across Main Street.

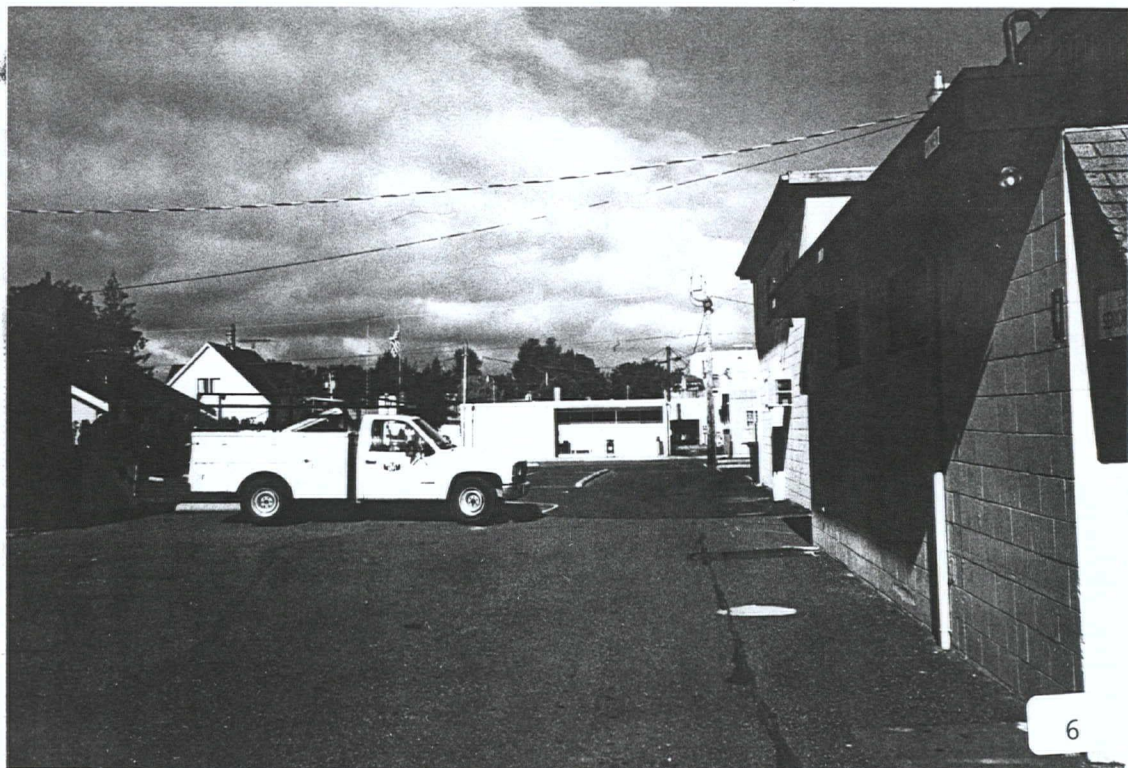
6) Looking west from alley at southeast corner of senior citizens' center.

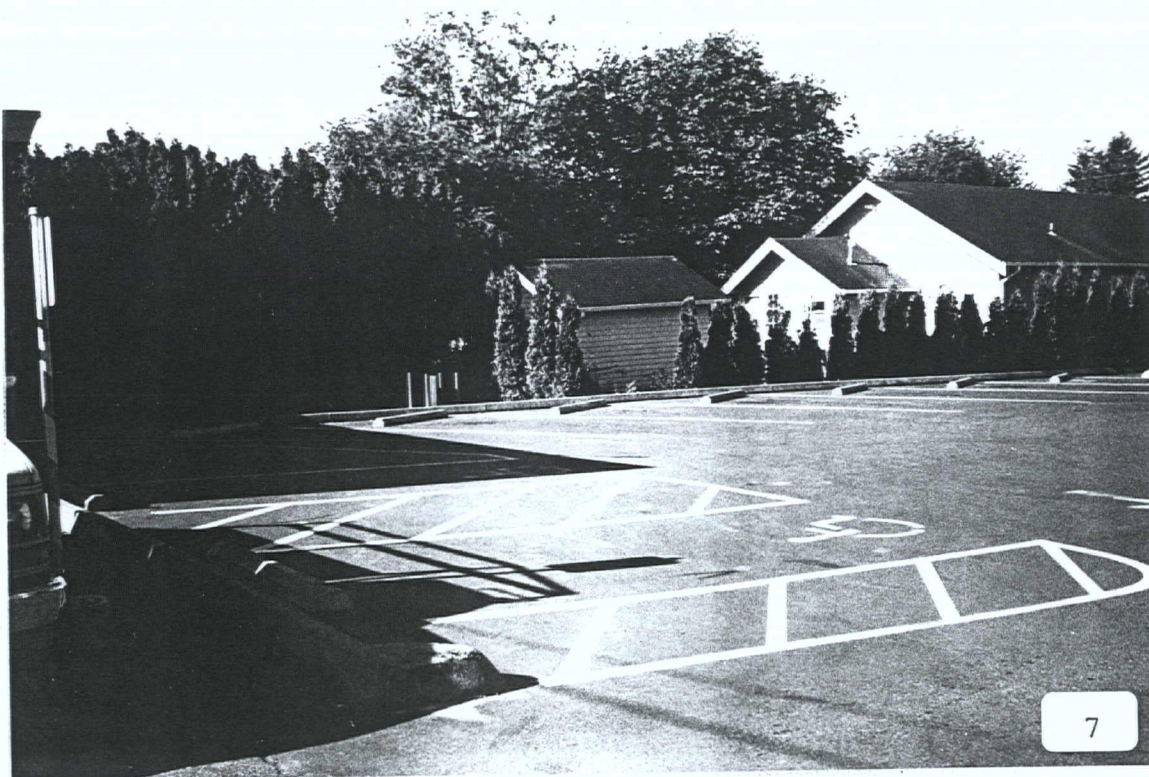
7) Looking southwest from southwest corner of City Hall.

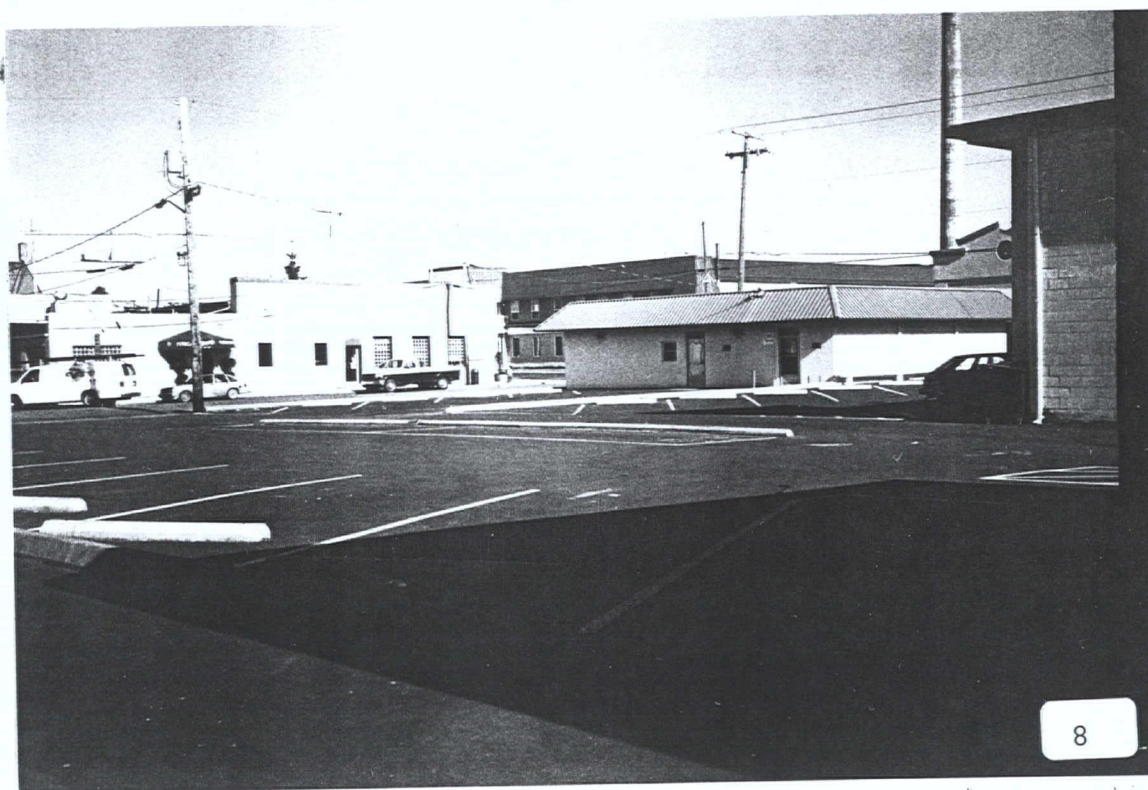
8) Looking northwest from southwest corner of city maintenance shoe.

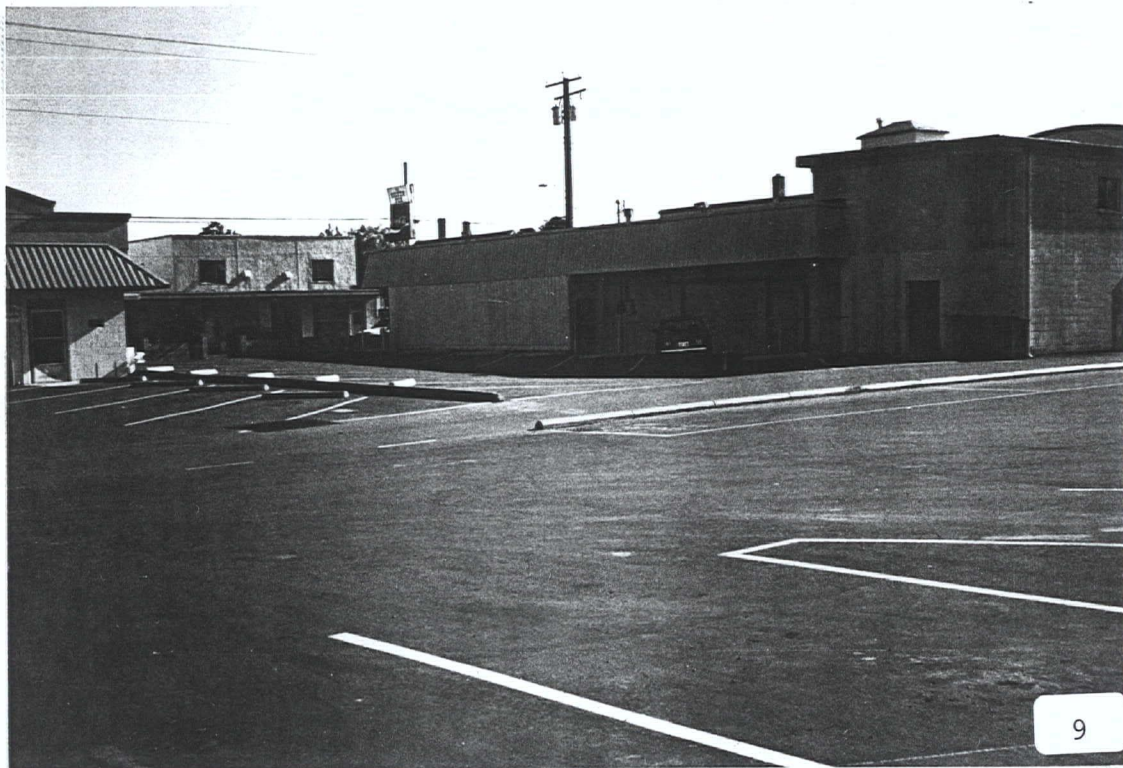
9

9) Looking northeast from MWB.
